The CVE-ID tracking this issue is: CVE-2020-3702

## **Description**

This advisory documents the impact of a vulnerability in the 2.4GHz radios of Arista Wireless Access Points (APs). Not all systems are impacted, please refer to the "Affected Platforms", and "Symptoms" sections below for specific required configuration to be vulnerable.

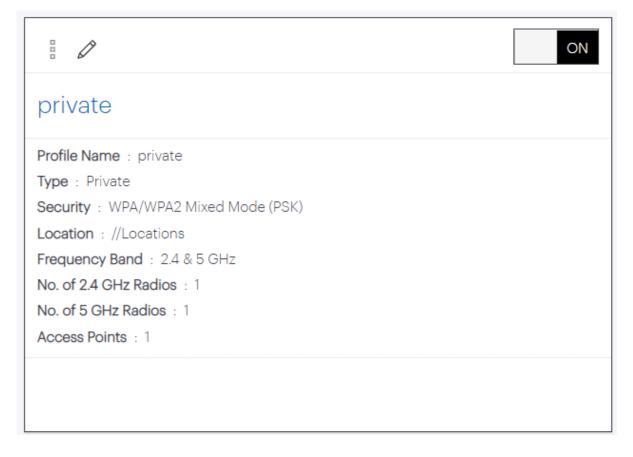
Example (The following SSID is configured to operate in both the 2.4GHz and 5 GHz bands, this is also an example of vulnerable configuration):

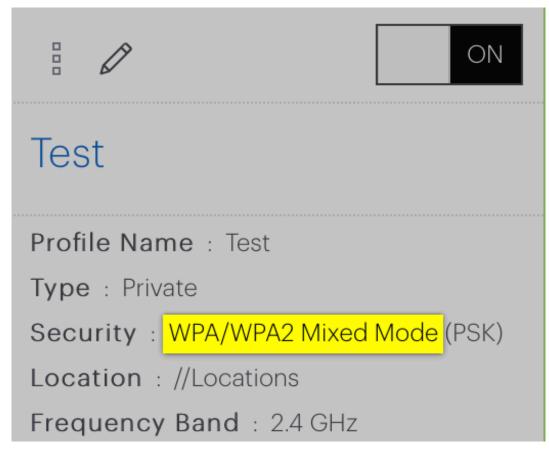
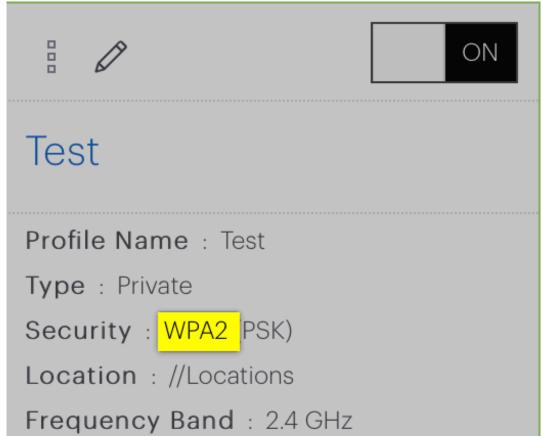
Note: As observed in the above examples, this vulnerability is applicable if either WPA2 mode or WPA/WPA2 mixed mode security standards are configured for the 2.4GHz SSID(s).
