Date:December 16th, 2020

The CVE-ID tracking this issue is: CVE-2020-3702

Description

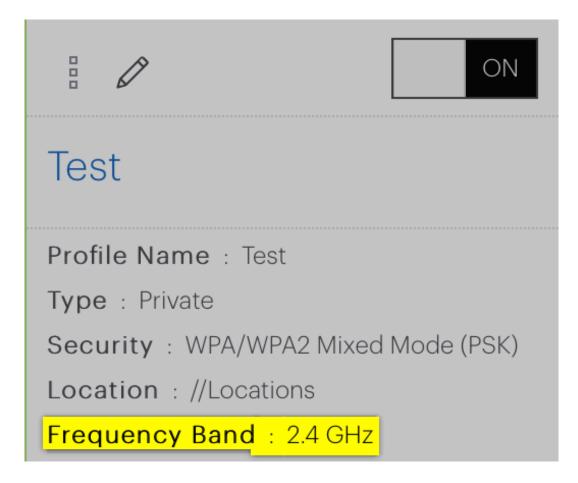
Example (GHz highlighted in yellow):

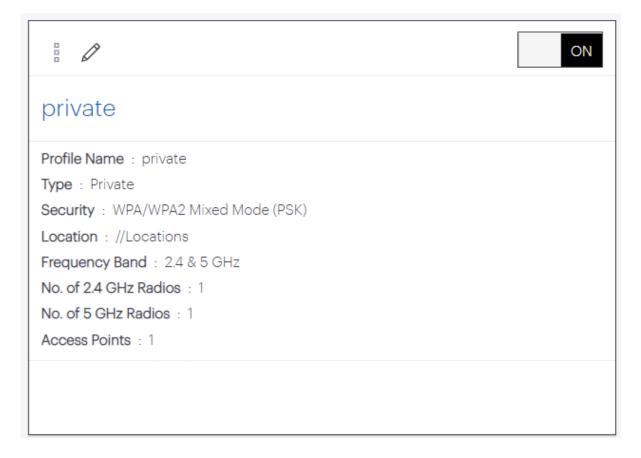
Example (The following SSID is configured to operate in both the 2.4GHz and 5 GHz bands, this is also an example of vulnerable configuration):

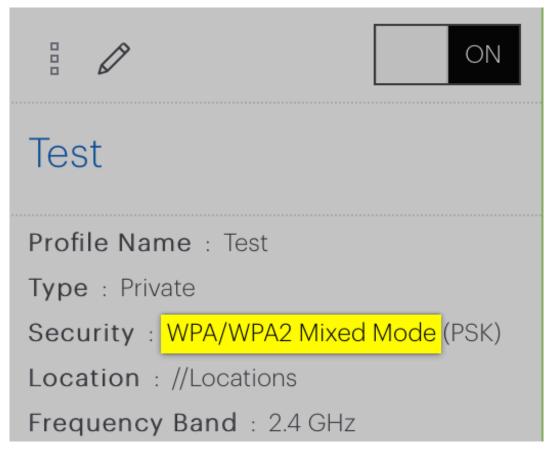
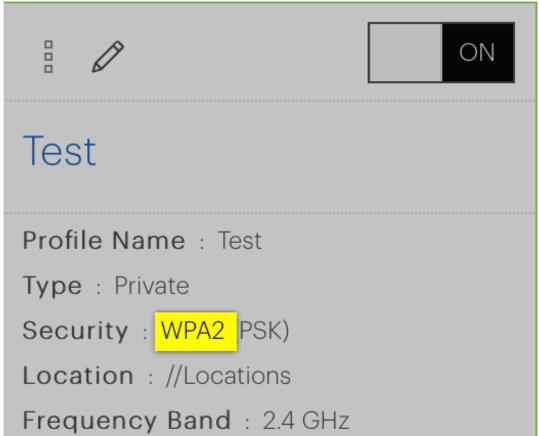
Note: As observed in the above examples, this vulnerability is applicable if either WPA2 mode or WPA/WPA2 mixed mode security standards are configured for the 2.4GHz SSID(s).
