The CVE-ID tracking this issue is: CVE-2020-3702

## Description

This advisory documents the impact of a vulnerability in the 2.4GHz radios of Arista Wireless Access Points (APs). Not all systems are impacted, please refer to the “Affected Platforms”, and “Symptoms” sections below for specific required configuration to be vulnerable.

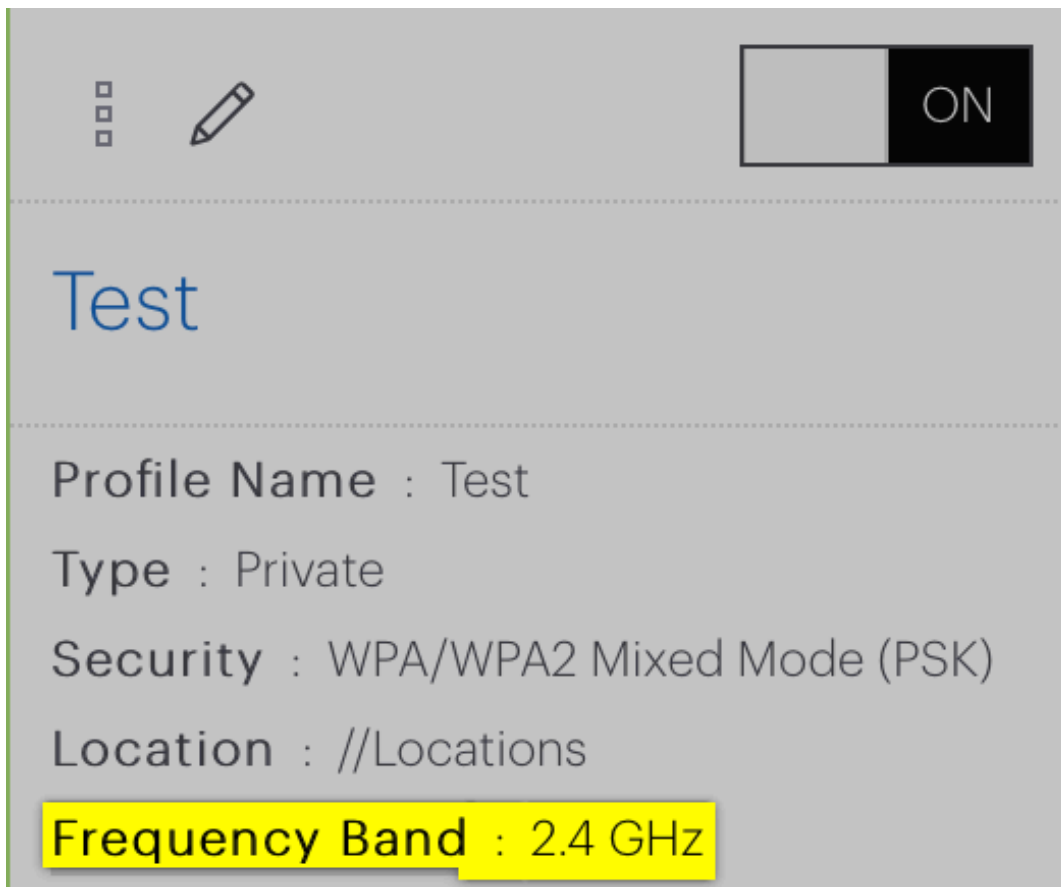
- Login to the CloudVision Wi-Fi GUI.
- Navigate to Configure -> SSID.
- Observe the SSID(s) configured to operate in the 2.4GHz band:

Example (GHz highlighted in yellow):

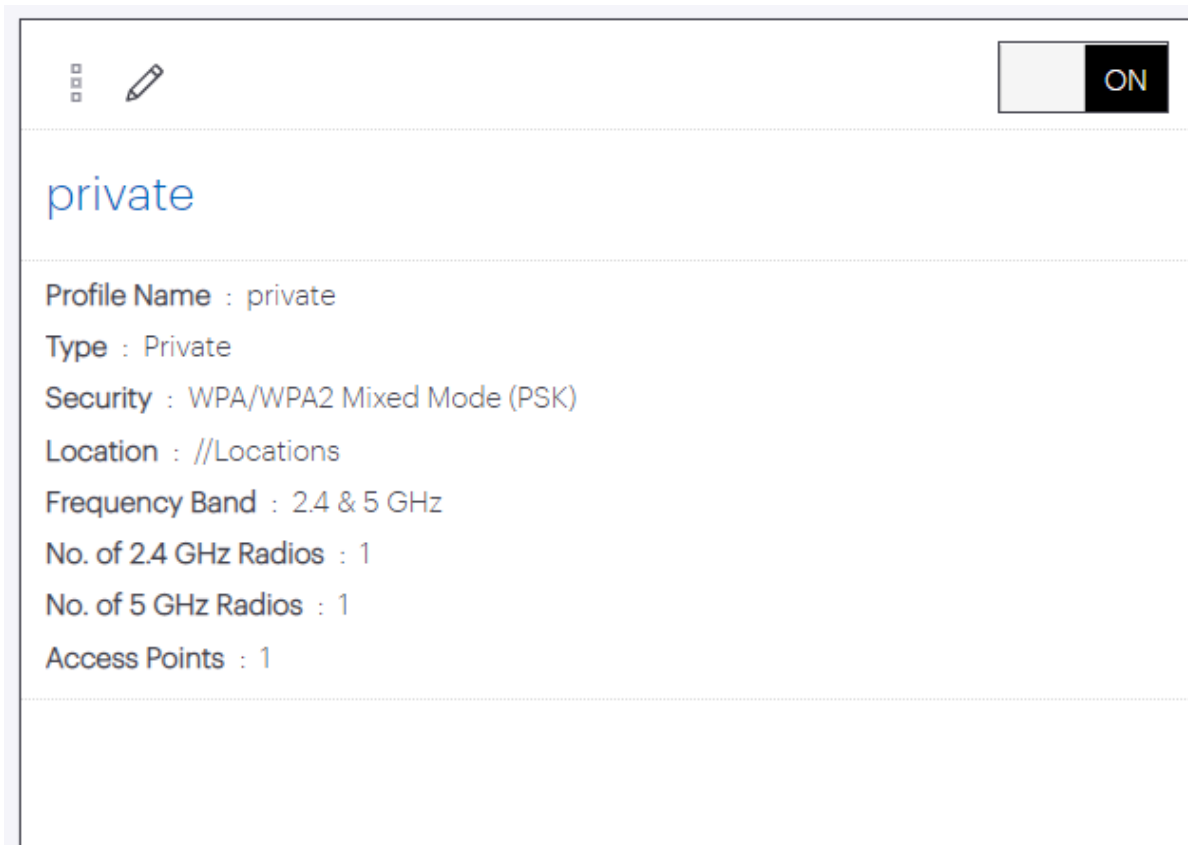
Example (The following SSID is configured to operate in both the 2.4GHz and 5 GHz bands, this is also an example of vulnerable configuration):
