Date:December 16th, 2020

The CVE-ID tracking this issue is: CVE-2020-3702

This advisory documents the impact of a vulnerability in the 2.4GHz radios of Arista Wireless Access Points (APs). Not all systems are impacted, please refer to the "Affected Platforms", and "Symptoms" sections below for specific required configuration to be vulnerable.

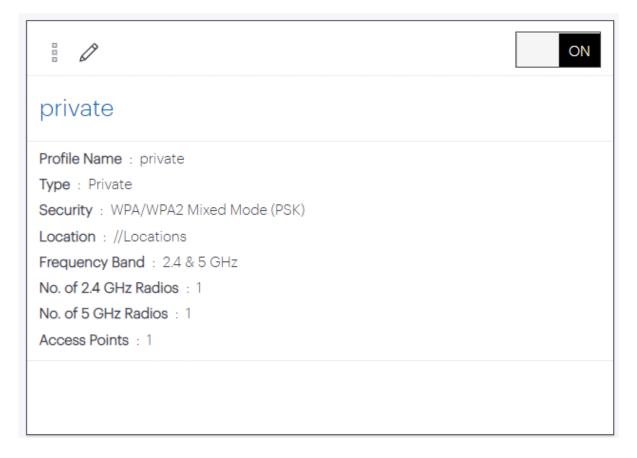
Example (The following SSID is configured to operate in both the 2.4GHz and 5 GHz bands, this is also an example of vulnerable configuration):

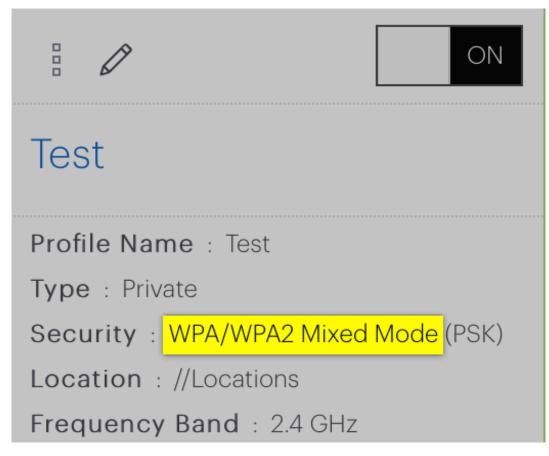
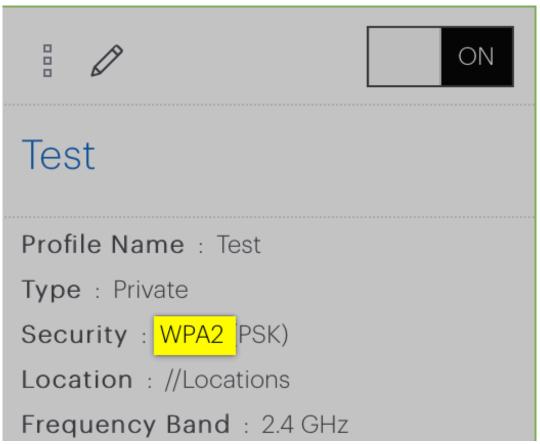
Note: As observed in the above examples, this vulnerability is applicable if either WPA2 mode or WPA/WPA2 mixed mode security standards are configured for the 2.4GHz SSID(s).
