Date: December 16th, 2020

The CVE-ID tracking this issue is: CVE-2020-3702

Description

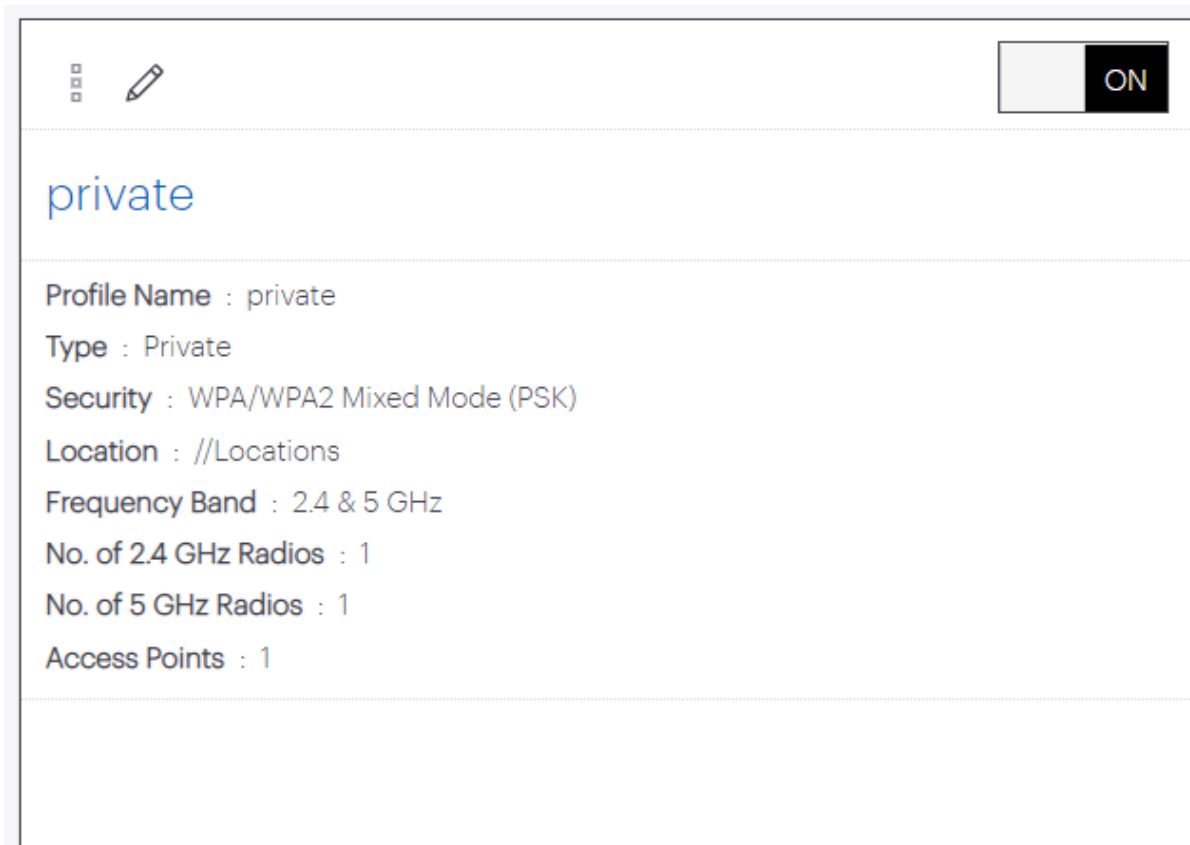
Example (The following SSID is configured to operate in both the 2.4GHz and 5 GHz bands, this is also an example of vulnerable configuration):
