The CVE-ID tracking this issue is: CVE-2020-3702

Description

This advisory documents the impact of a vulnerability in the 2.4GHz radios of Arista Wireless Access Points (APs). Not all systems are impacted, please refer to the “Affected Platforms”, and “Symptoms” sections below for specific required configuration to be vulnerable.

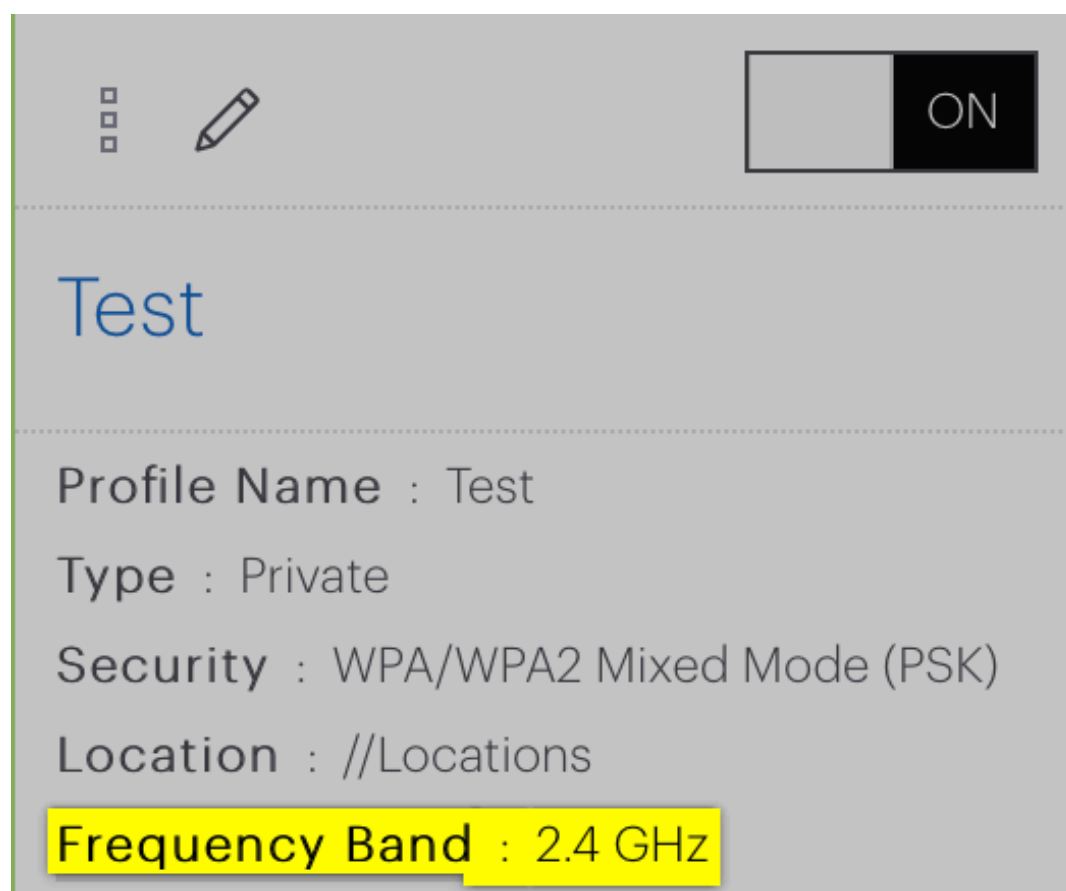
2) Confirm if a SSID(s) has been configured to operate in the 2.4GHz band.

Example (GHz highlighted in yellow):
