Date:December 16th, 2020

The CVE-ID tracking this issue is: CVE-2020-3702

This advisory documents the impact of a vulnerability in the 2.4GHz radios of Arista Wireless Access Points (APs). Not all systems are impacted, please refer to the "Affected Platforms", and "Symptoms" sections below for specific required configuration to be vulnerable.

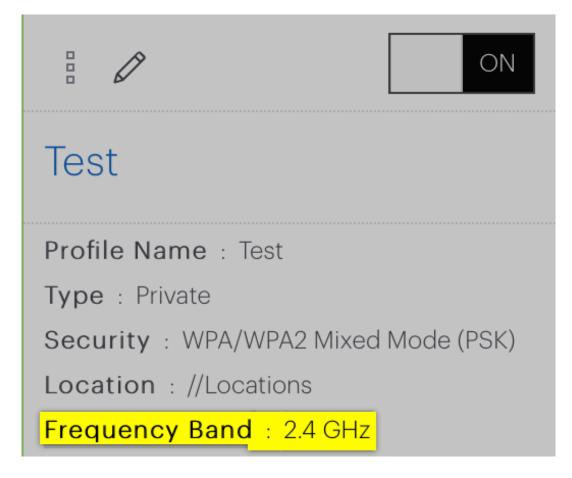
- Login to the CloudVision Wi-Fi GUI.
- Navigate to Configure -> SSID.
- Observe the SSID(s) configured to operate in the 2.4GHz band:

Example (GHz highlighted in yellow):

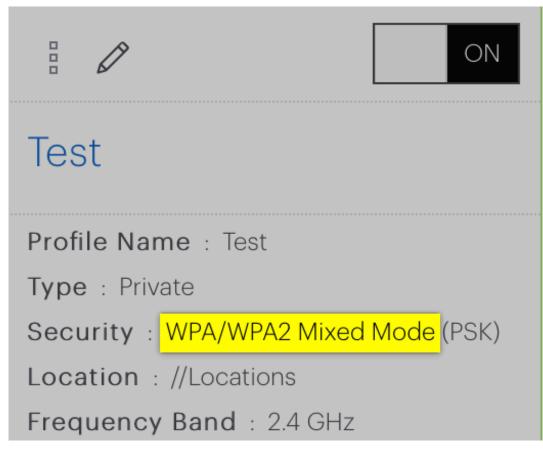
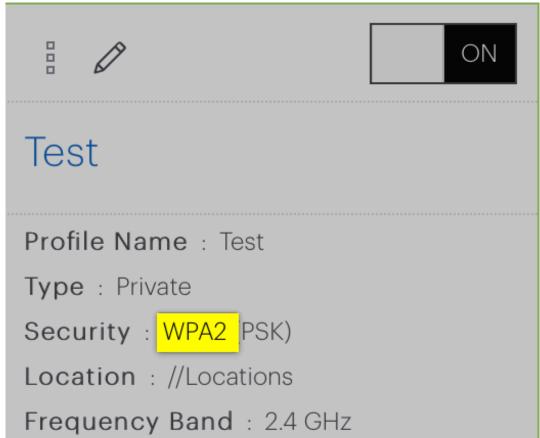
- Login to the CloudVision Wi-Fi GUI
- Navigate to Configure -> SSID.
- Observe the security standard configured for the 2.4GHz SSID(s):

Note: As observed in the above examples, this vulnerability is applicable if either WPA2 mode or WPA/WPA2 mixed mode security standards are configured for the 2.4GHz SSID(s).
