The CVE-ID tracking this issue is: CVE-2020-3702

This advisory documents the impact of a vulnerability in the 2.4GHz radios of Arista Wireless Access Points (APs). Not all systems are impacted, please refer to the “Affected Platforms”, and “Symptoms” sections below for specific required configuration to be vulnerable.

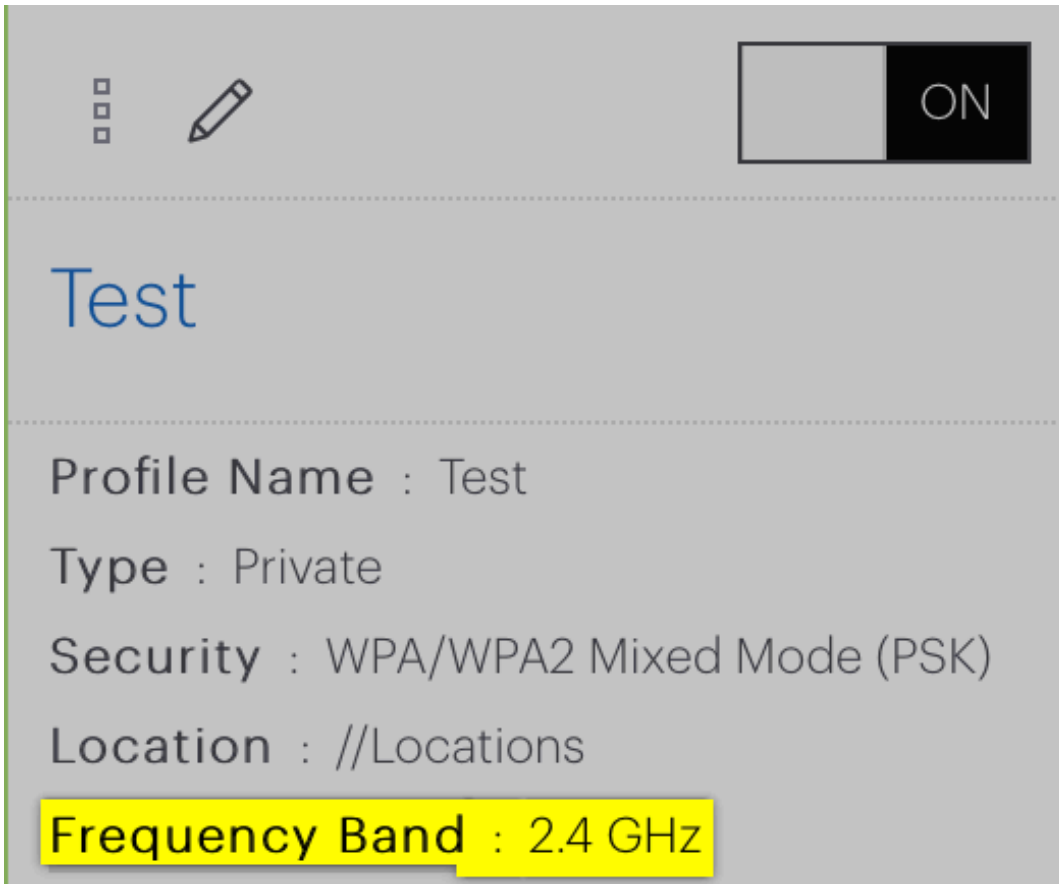
Example (GHz highlighted in yellow):
