Date:December 16th, 2020

The CVE-ID tracking this issue is: CVE-2020-3702

Description

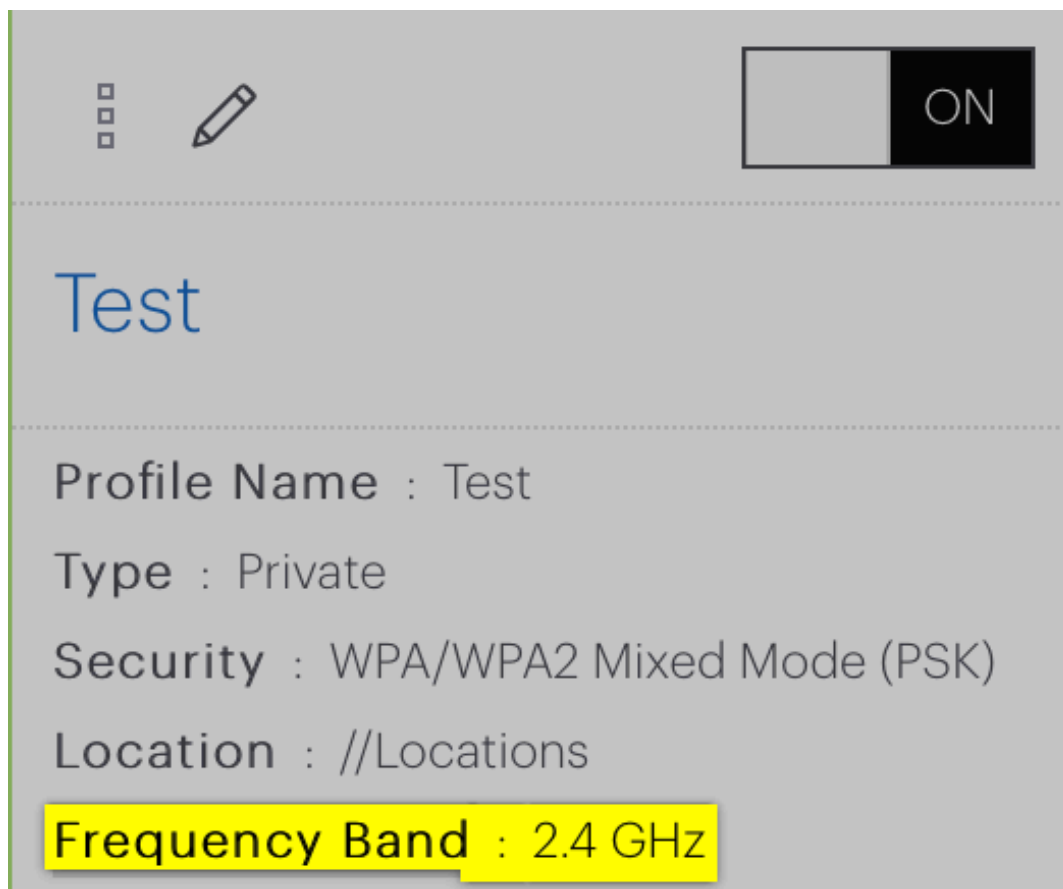
Example (GHz highlighted in yellow):
