Date:December 16th, 2020

Version: 1.0

The CVE-ID tracking this issue is: CVE-2020-3702

Description

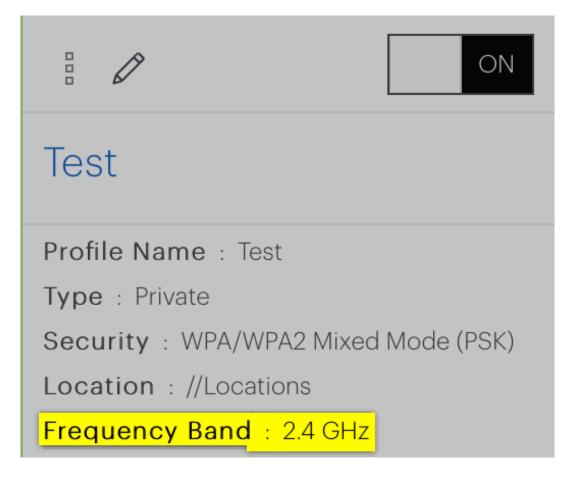
Example (GHz highlighted in yellow):

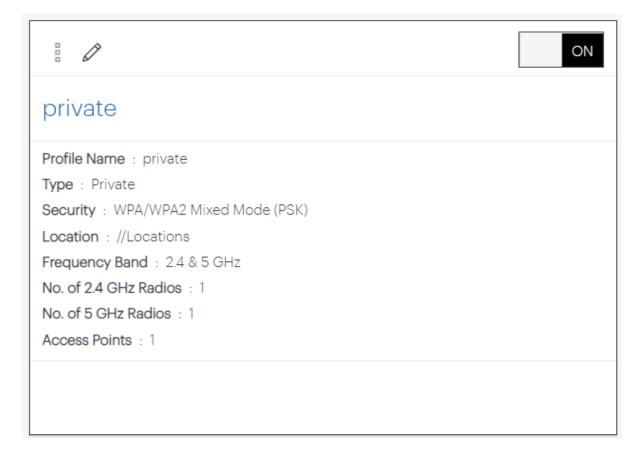
Example (The following SSID is configured to operate in both the 2.4GHz and 5 GHz bands, this is also an example of vulnerable configuration):

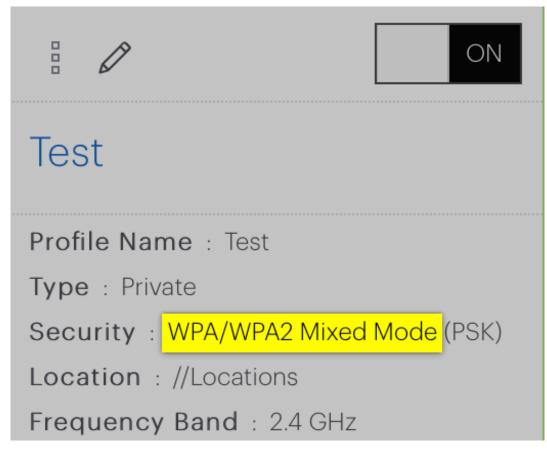
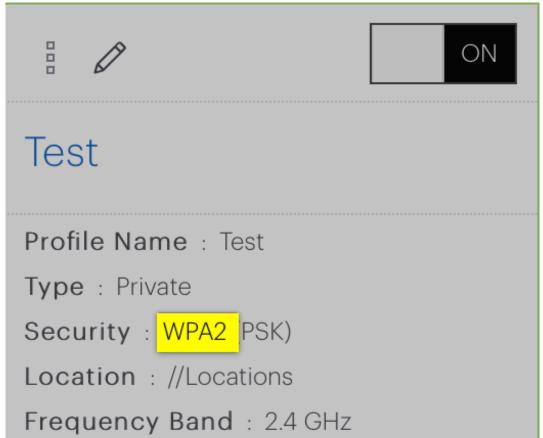
Note: As observed in the above examples, this vulnerability is applicable if either WPA2 mode or WPA/WPA2 mixed mode security standards are configured for the 2.4GHz SSID(s).
