Date:December 16th, 2020

The CVE-ID tracking this issue is: CVE-2020-3702
CVSSv3.1 Base Score: 7.5 (CVSS:3.1/AV:N/AC:L/PR:N/UI:N/S:U/C:H/I:N/A:N)

Description

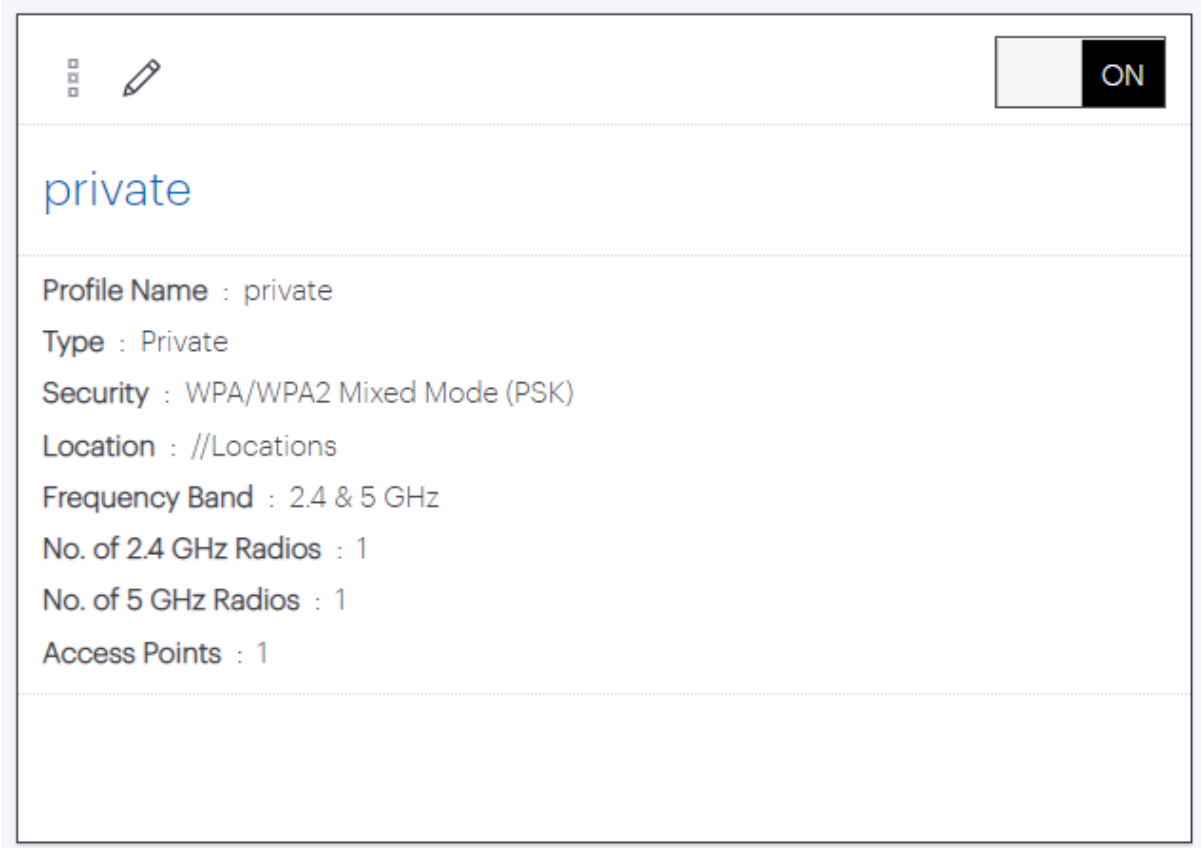
Example (The following SSID is configured to operate in both the 2.4GHz and 5 GHz bands, this is also an example of vulnerable configuration):

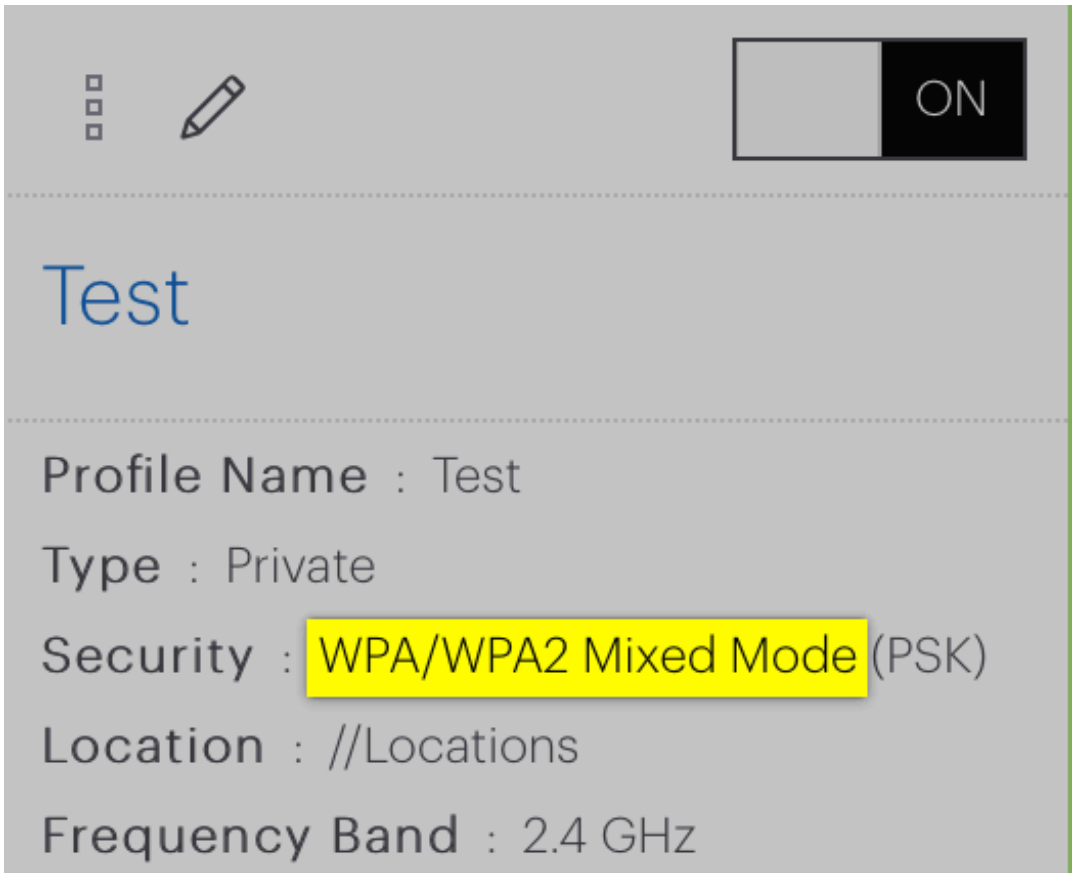
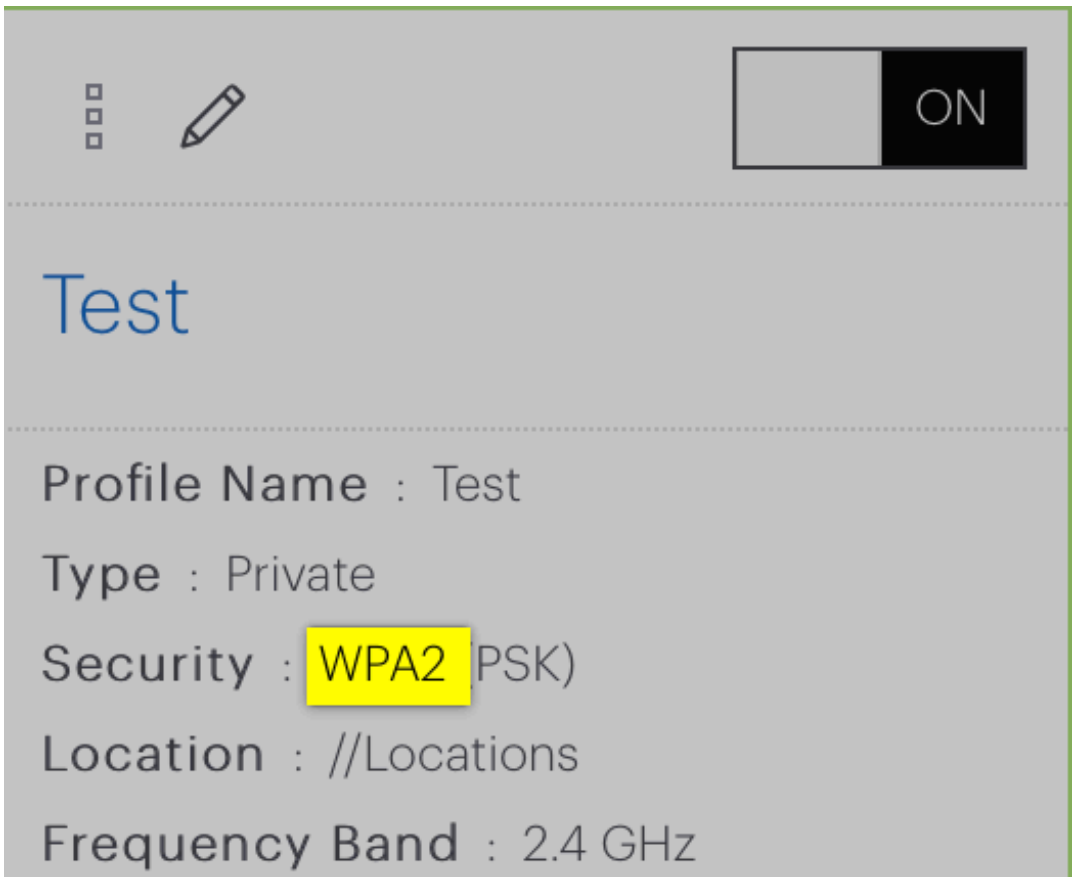
- Login to the CloudVision Wi-Fi GUI
- Navigate to Configure -> SSID.
- Observe the security standard configured for the 2.4GHz SSID(s):

Note: As observed in the above examples, this vulnerability is applicable if either WPA2 mode or WPA/WPA2 mixed mode security standards are configured for the 2.4GHz SSID(s).

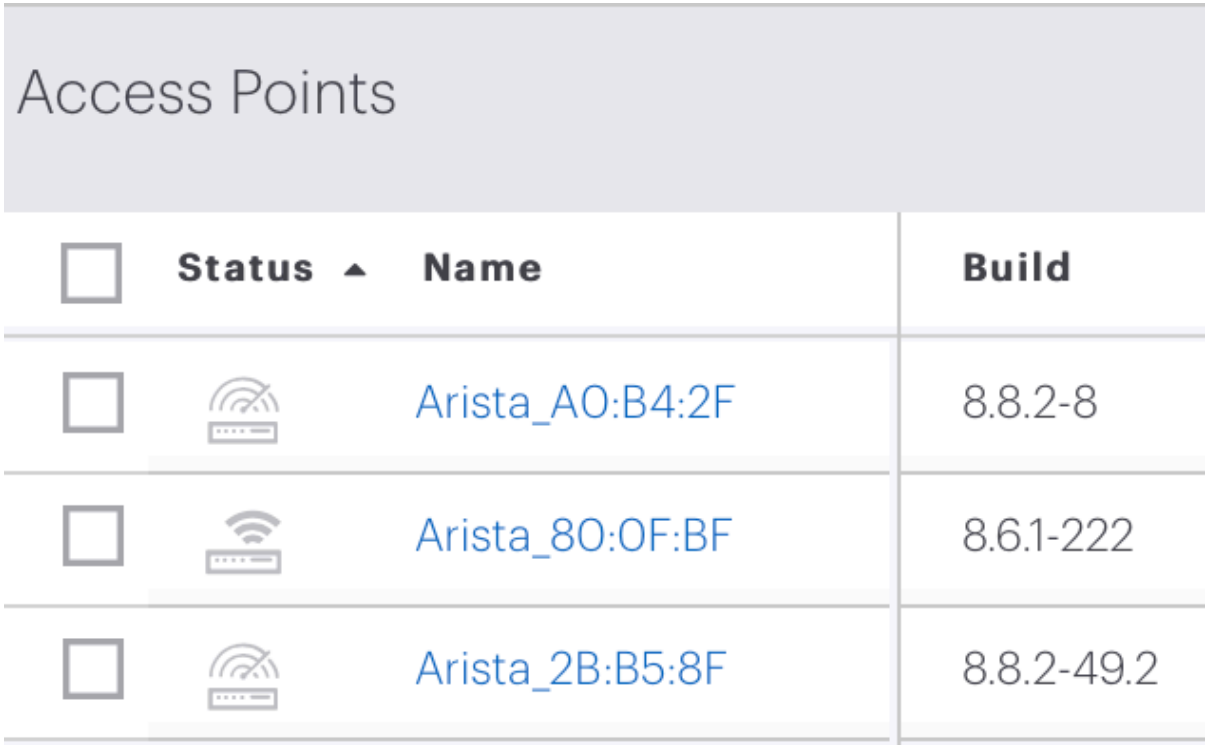
- Login to the CloudVision Wi-Fi GUI.
- Navigate to Monitor -> Wi-Fi -> Access Points.
- Observe the AP Build version under the “Build” column:

- Confirm that the build version used is one listed under the “Affected Software” section.
